Kongsborg Accident

IMCA Safety Flash 03/16

Accient on-board Kongsborg on the 25th of August 2015

Lost Time Injury (LTI): Stored Pressure Release - Crewman Lost an Eye

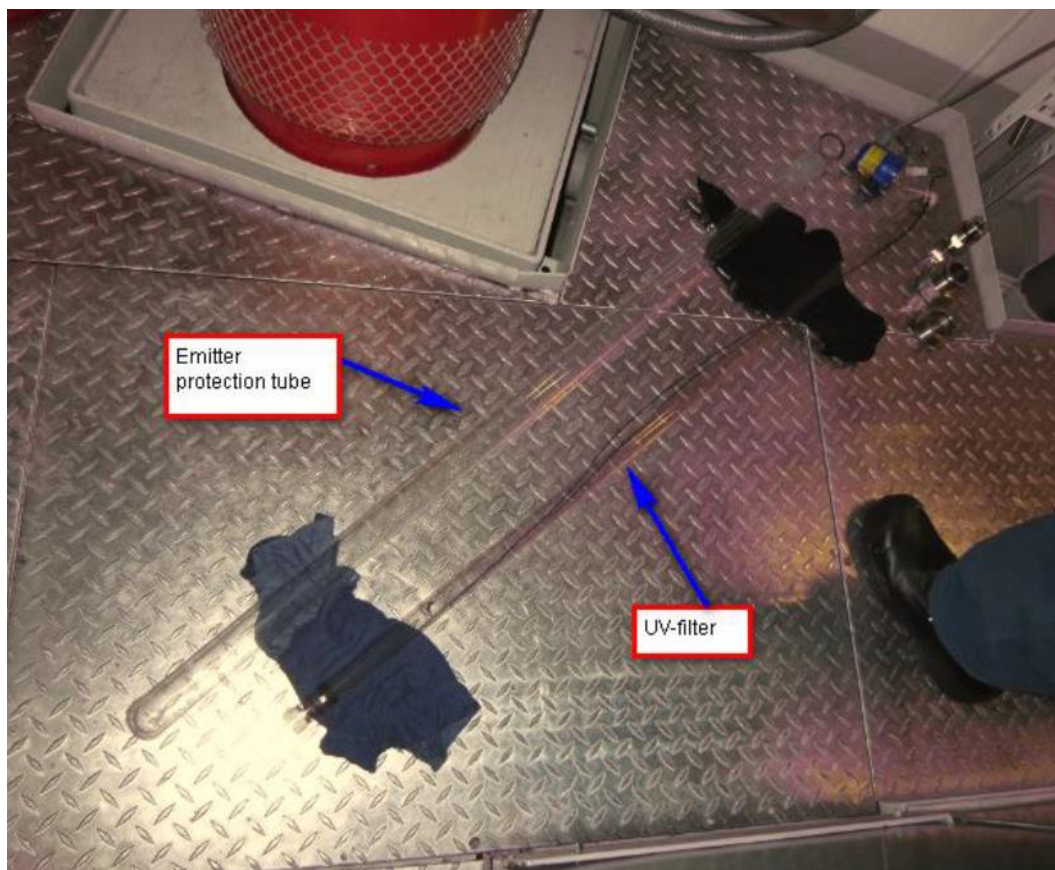
Emitter tube and UV-filter ready to be inserted

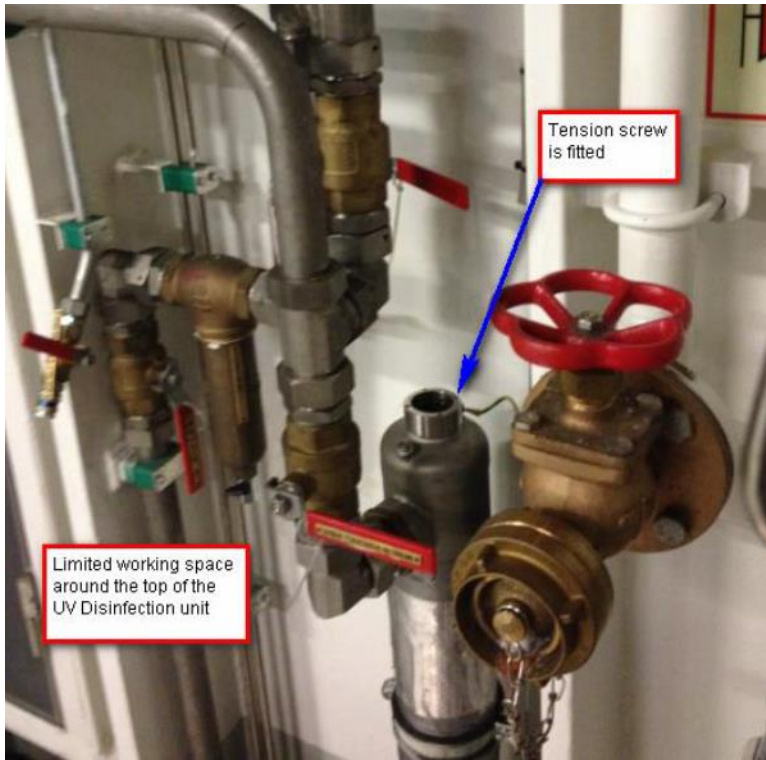
Investigations revealed the inlet valve was approximately 1/3 open

- Type of valves – It was possible to open the water inlet valve by accident due to the type of valve handle, which led to water running into the UV disinfection unit and building up a pressure below the emitter protection tube. This resulted in the emitter protection tube being forced out through the opening in the tension screw with high speed, hitting the 2nd Engineer in the face;

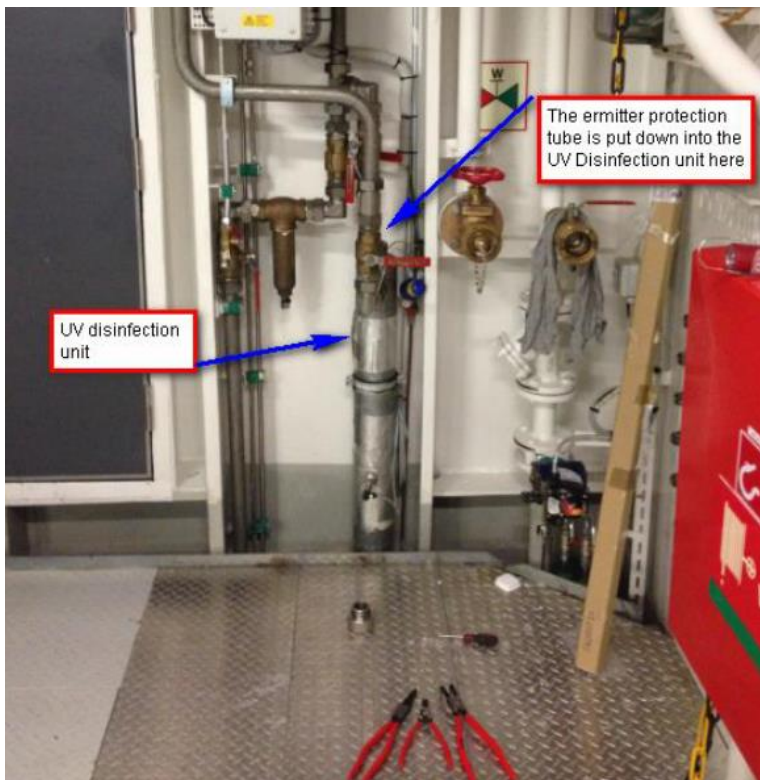
Actual system on-board.

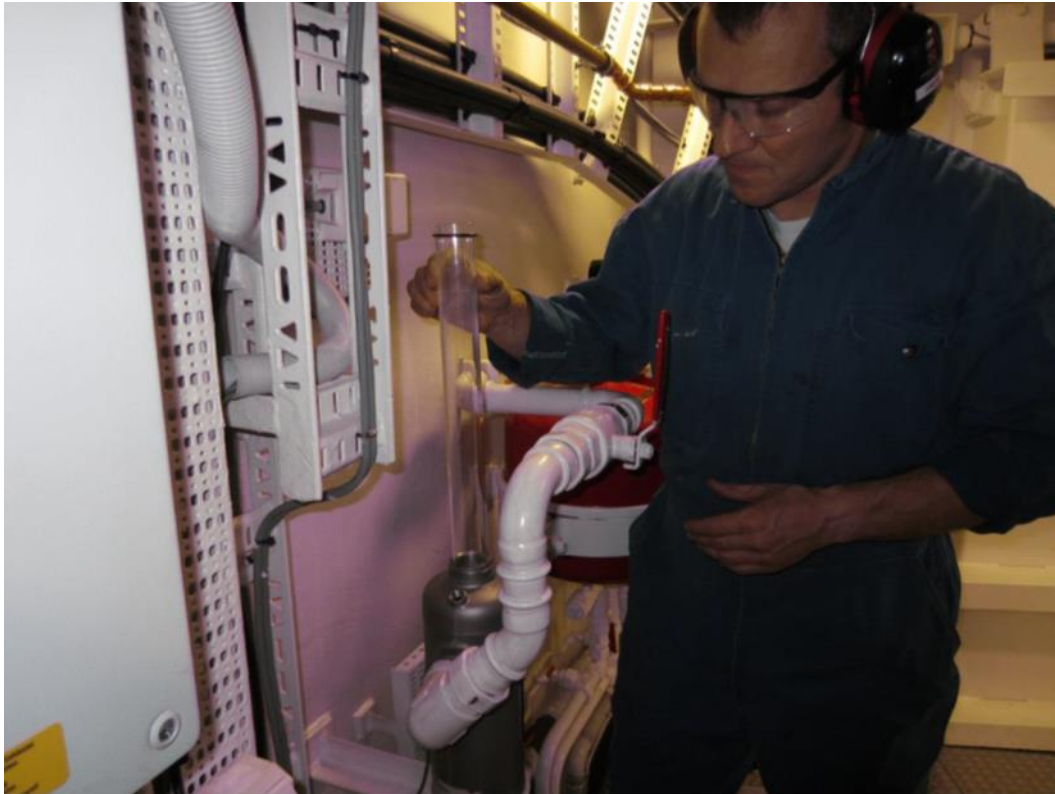
Emitter protection tube lowered into the filter (picture from another vessel).
