MV Varðborg

Marine Casualty Investigation report

Fire onboard fishing vessel “Varðborg”.

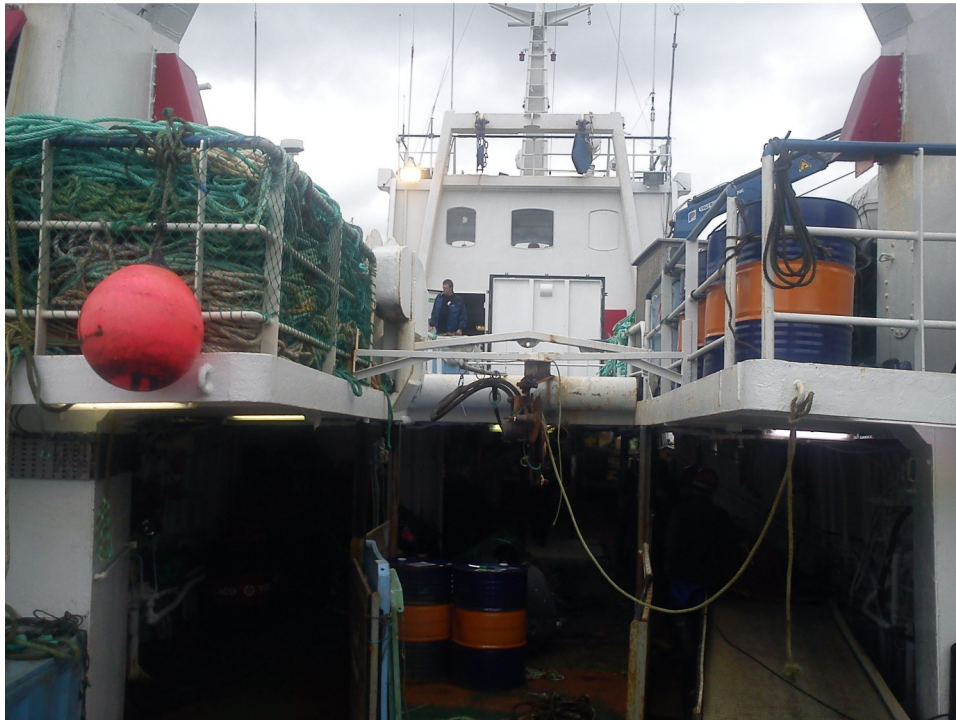
Then he took his way aft the boat deck, and noticed smoke coming from the aft end of the vessel.

Aft end Navigation Bridge, boat deck and main deck.

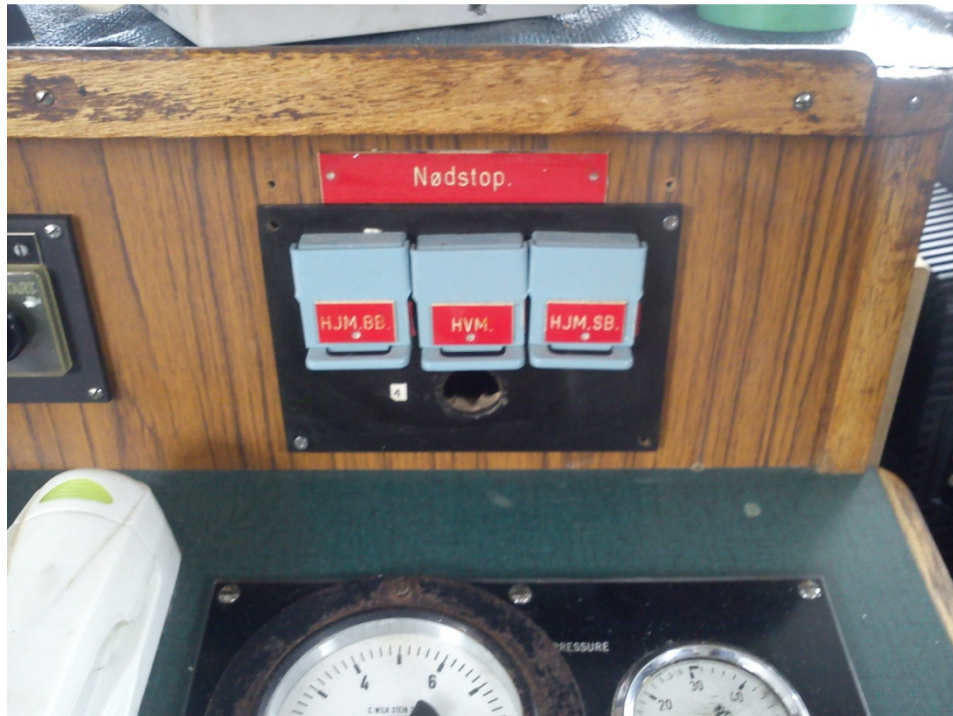
Emergency Stop panel Navigation Bridge

While the auxiliary engines stopped, the main engine did not stop.

Since the main engine did not stop on initial activation M.E. emergency stop button, the Captain instructed the Mate to activate the M.E. emergency stop button, at short intervals. However, without effect. The main engine kept running at 200 to 400 rpm/min.

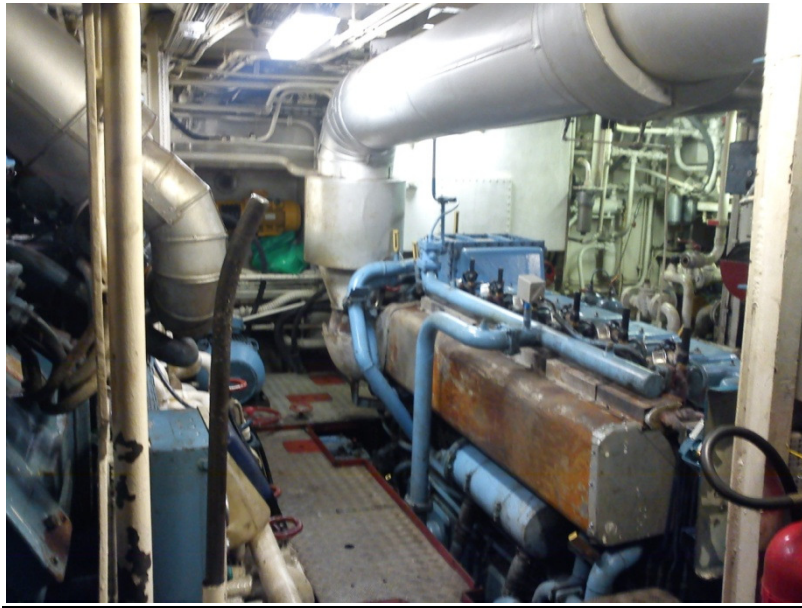
The engine room. Main engine to the right.

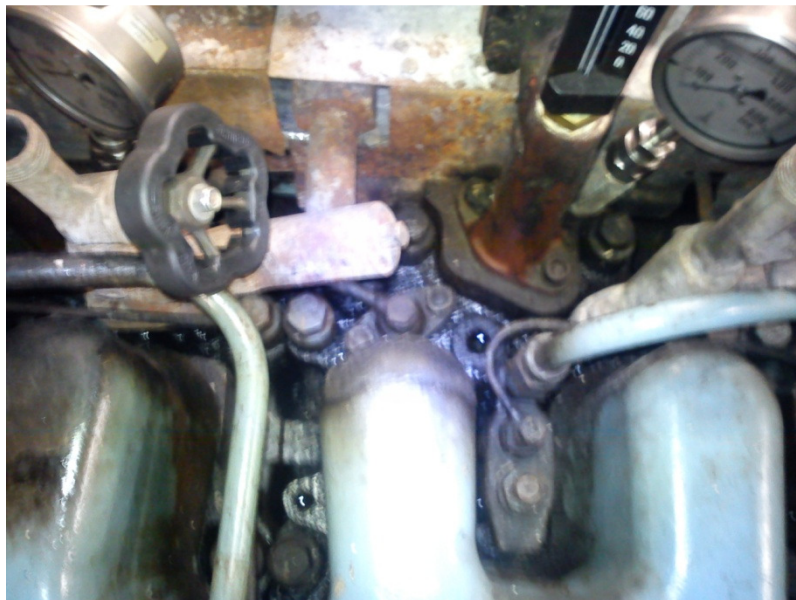
Direct cause of the fire was lubricating oil spraying onto hot surfaces exhaust manifold, engine block and cylinder heads main engine.

M.E. Cylinder head 4 & 5 -and top cover exhaust manifold

Since this is a pressurized system, warm lub oil was sprayed up into area between the exhaust manifold and cylinder heads four and five, after which it ignited.

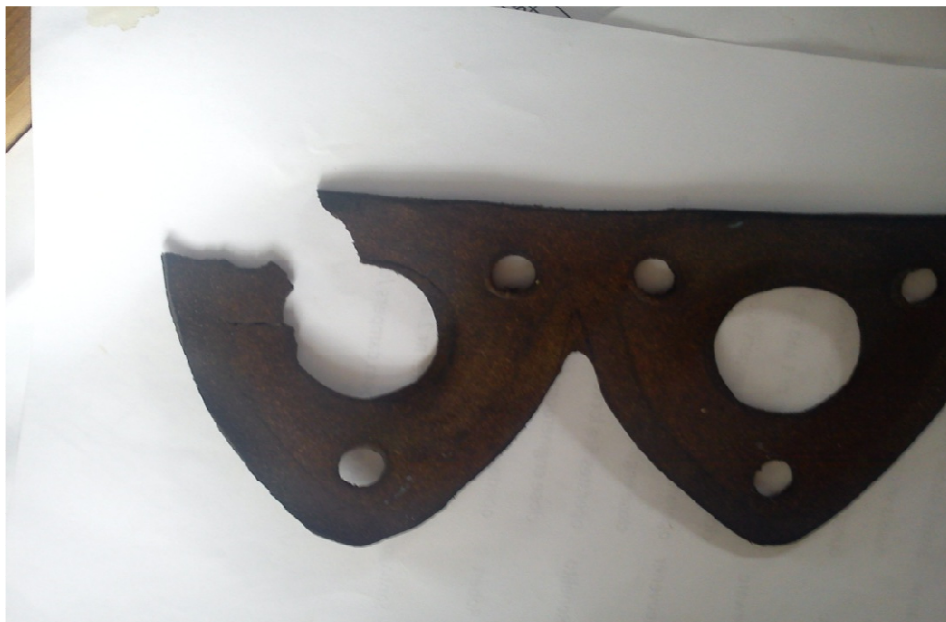
1) Newly installed gasket blown/broken

- a) *The gasket used was made by cork materiel.
Gaskets made by Cork are most likely not thoroughly able withstanding pressure and temperature conditions in mentioned system.*
- b) *During repair in Peterhead, bolts might not have been adjusted to even tightness, causing only parts of gasket to be thoroughly secured.*

The broken gasket

- 1)** Gaskets used in high and fluctuating temperatures and pressure ranges should be made of enforced rubber or similar. Cork gaskets are not considered to meet the requirements.
- 2)** All safety alarms, emergency stops, etc., related to safe operation of the vessel should be tested at intervals of maximum three months.

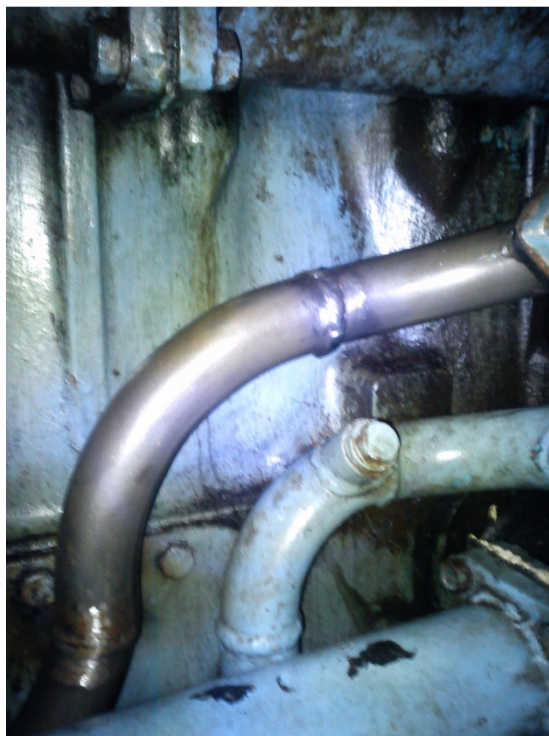
During repair work after the fire it was noticed the pipe next to the blown sealing was cracked. Reason for crack(s) might be:

a) Corrosion/wear

b) Unevenly tightened bolts, thus adverse tensions.

The new pipe which replaced the broken one

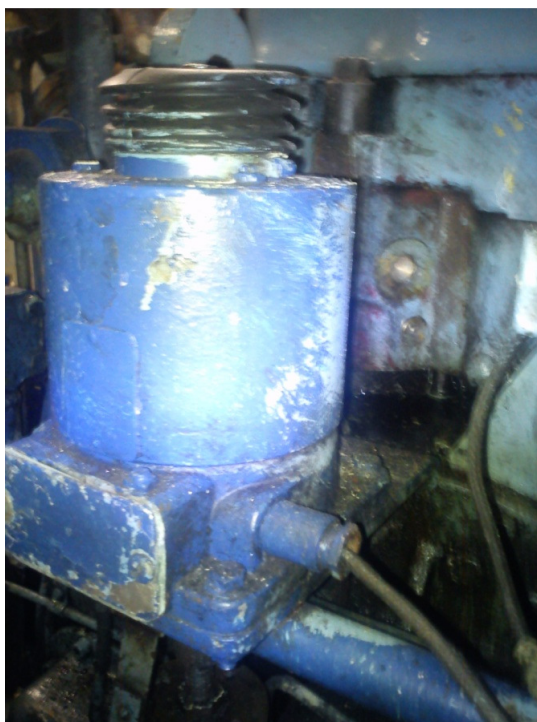
Main engine emergency stop unit

Investigations carried out reveal the connection between Navigation Bridge and M.E emergency stop unit was broken.

The cable inside the emergency stop unit, located at back end of the main engine was damaged.

Thus the M.E. shut down switch on the Navigation Bridge was inoperative.

The reason for this deficiency is most likely wear due to age and/or vibrations.

- Main engine emergency stop,
- Aux engine emergency stop,
- Main Engine slow down,
- Quick closing valves,

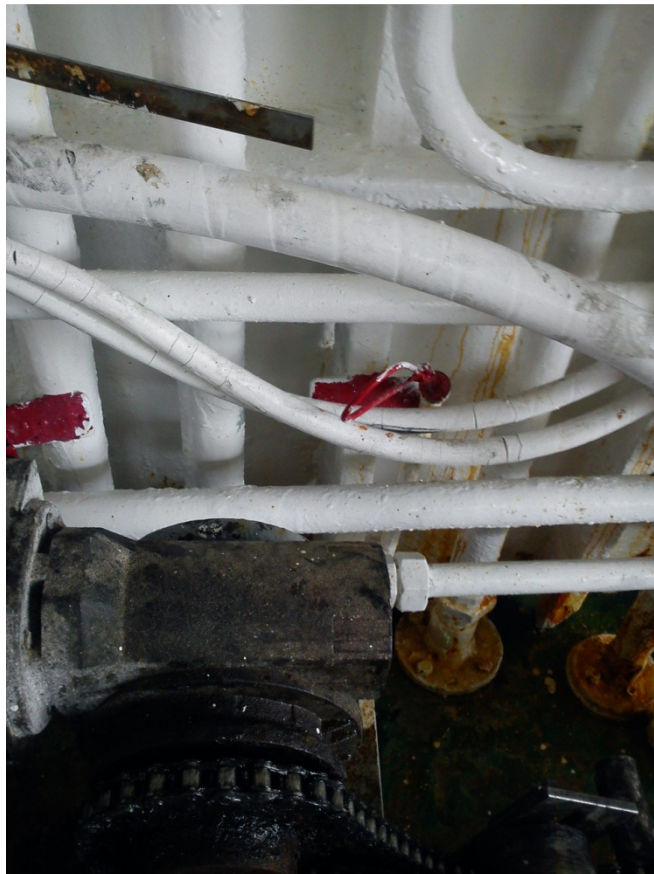
Remote for quick closing valve day tank. Located main deck SB.

Since there was minimum load on the main engine, fuel and air consumption for combustion was at a minimum. Thus, it is estimated that fuel already inside system was consumed before main engine stopped.

Likewise, it is estimated that air inside engine room and minor airflow into engine room have contributed to the main engine running for 23 minutes.
