MV Havfrakt

Marine Casualty Investigation report

**Grounding of MV Havfrakt onto Island of Olaholmen,
Norway, 24.10.2010.**

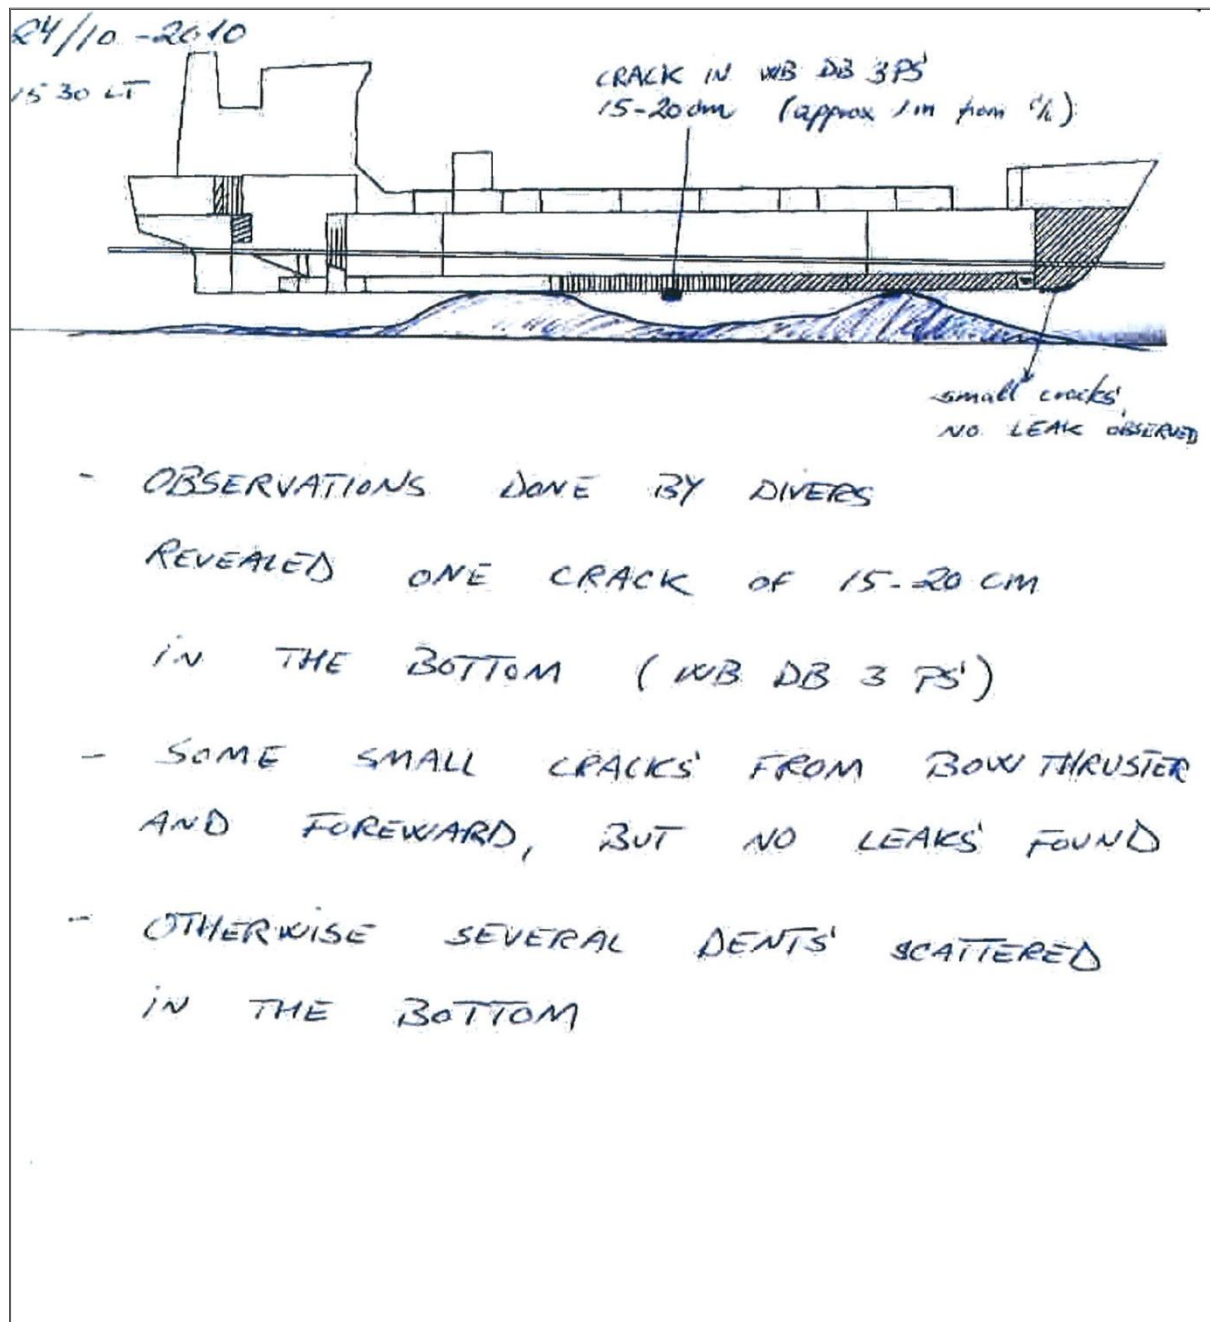
Attachment No.2

Attachment no 2: Drawing - vessel sitting aground – report from divers

Diver inspections reveal that vessel's bottom plating is resting onto the seabed in two positions. See attachment no.2.

Skipaerumio <small>Faroese Maritime Authority</small>
Tá skipið sigldi á land		Vessel ground collision
10	Skaðafrágreiðing.	<i>Incident report.</i>
Ship bottom inspected by divers. One crack found in tank 3, Small indents found, and a few long stripes in the shell plates on tank 1 and forepeak.		
11	Seinasta knøttstøða, áðrenn tað setti. Knøttstøða tá tað setti. Nær og hvussu vóru knøttstøðurnar staðfestar?	<i>Last known possition prior to grounding/collition. Possition of incident site. Method and time of determining positions.</i>
At 0117 lt radar bearing was taken to "Klavskj. Leading light tower" 270° range 0,3Nm (Pos: 69°11'8N - 018°01'3E)		
12	Greinan av siglingini frá seinastu knøttstøðu, áðrenn tað setti til tað setti.	<i>Explination of navigation from last possition, from the last known possition, until the collition.</i>
When passing green light buoy at Finnesgr. Course was set to 000°. As of this moment the two green flashing lights have been in line, thus only one green flashing light was observed and the vessel was on planned track. When getting closer and having the green light on the port side, course was slightly altered to port in order to keep the green light on our starboard side. Here is where the misjudgement of lights happens, as the focus on the green light is set on the wrong light tower.

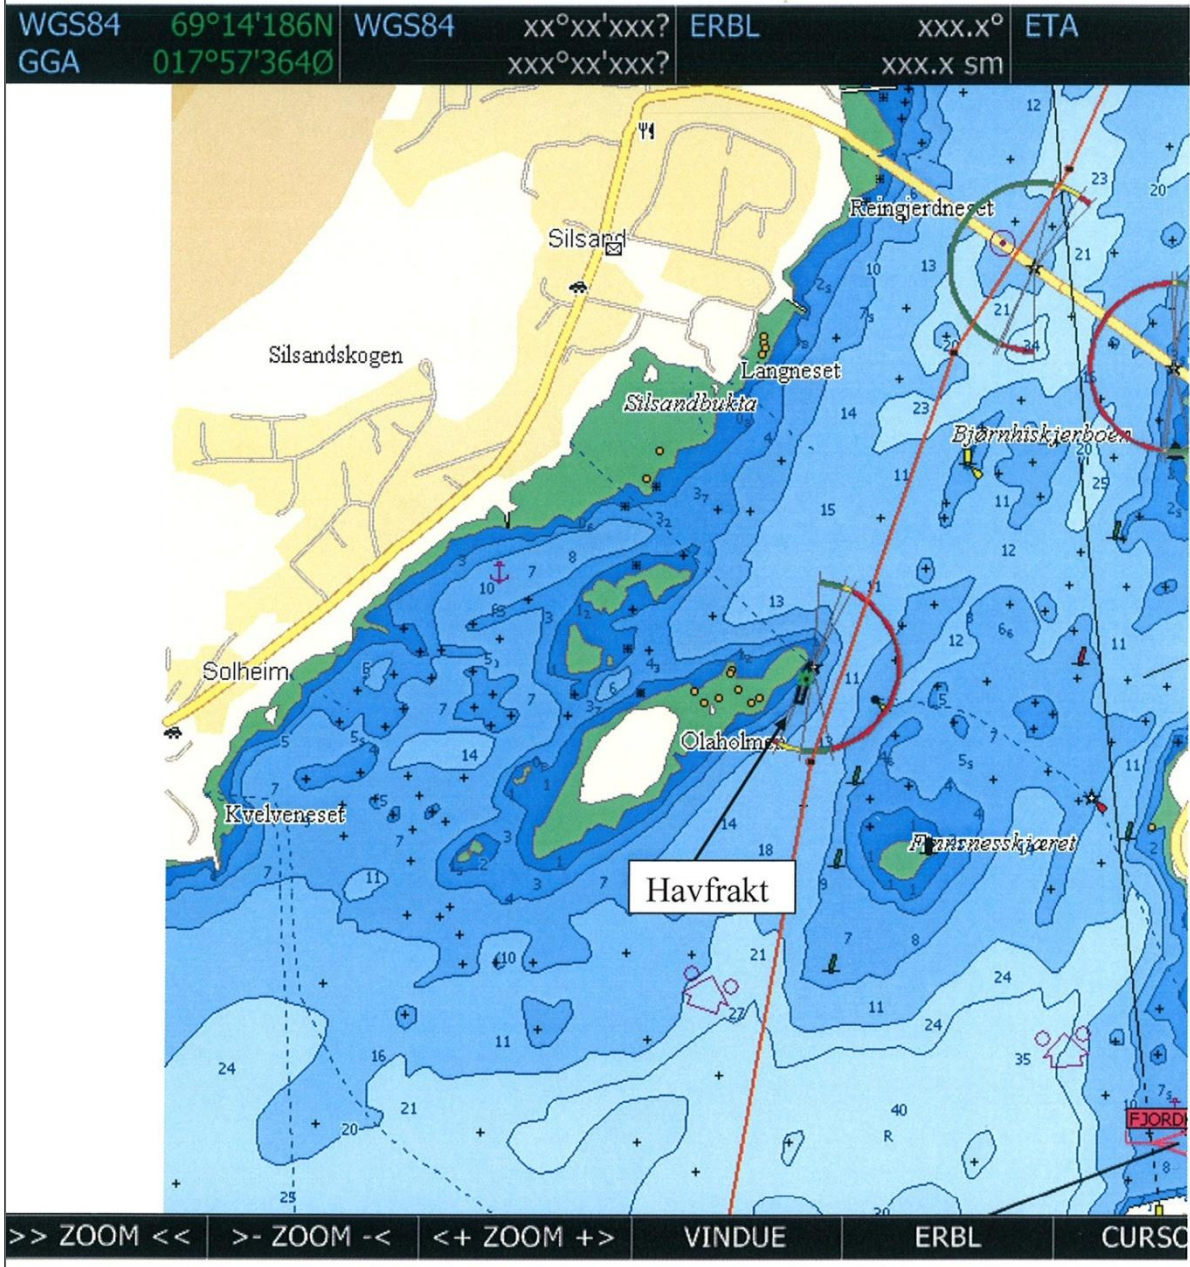
Attachment No.3

Attachment no 3: Extract from Electronic Chart MVHavfrakt
