Final report RS 2016:01e

BONDEN/ ASIAN BREEZE - collision in
the fairway off Malmö 16 March 2015

File no. S-37/15

22/03/2016

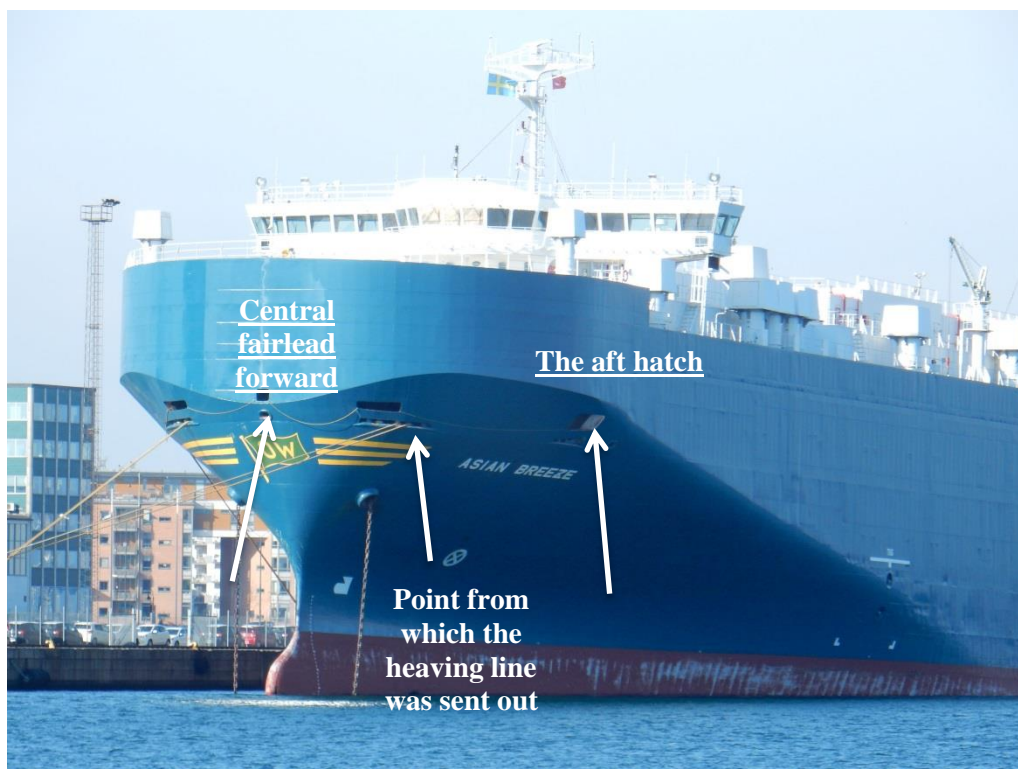
Figure 4. ASIAN BREEZE's forecastle.

The crew of ASIAN BREEZE attempted on two occasions to throw down their own messenger line without a sinker from the bow; i.e., from a position further forward than desired by the tugboat crew. The first attempt failed, and it was therefore agreed that BONDEN would instead go to ASIAN BREEZE's port side and make a fresh attempt from there. This time, the messenger line was successfully passed down to BONDEN, whose crew began preparing the connection. At this point, the car carrier had a speed of 2.5 knots.

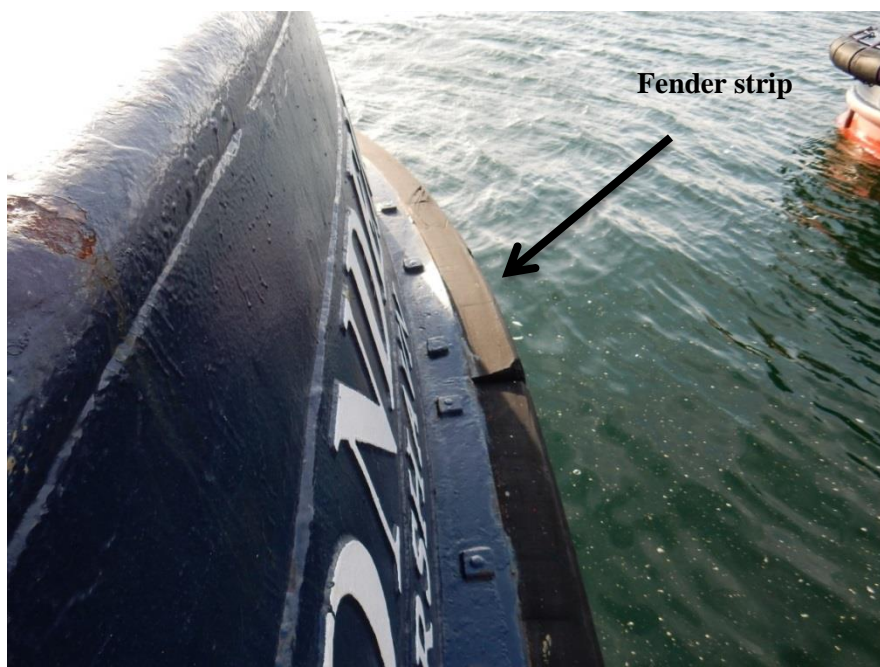
Figure 7. BONDEN's fender strip.

During the turn, however, the towline became stuck under BONDEN's own fender strip on the port side. This led the tugboat to perform an involuntary turn to port; see fig. 7. The master of BONDEN was thus forced to use the emergency release to quickly release the towline; see fig. 8.

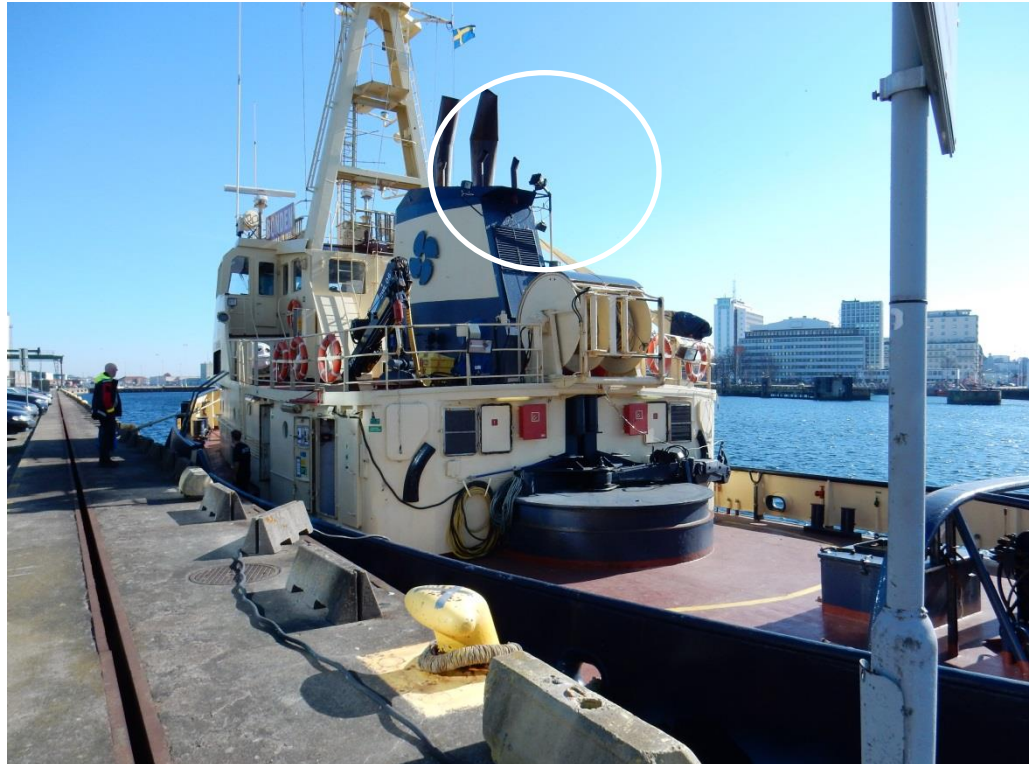
BONDEN received extensive damage to the propeller, propeller shaft and exhaust pipe, sheet metal damage to the aft hull and damage to a cord for a light. The damage was attended to in a visit to a shipyard.

Figure 9. *BONDEN*, damage to exhaust pipe and light.

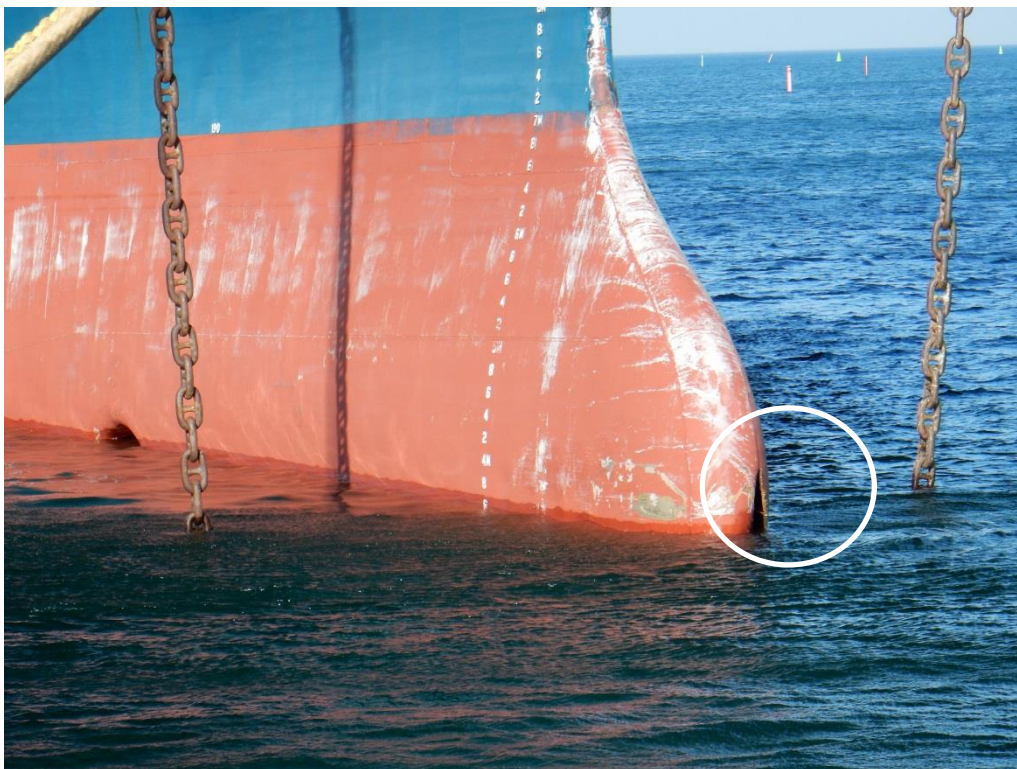
ASIAN BREEZE received a tear in its bulbous bow, close to the fore-peak, which is a ballast tank. The tank was empty at the time of the accident; see figure 10. The damage meant that the ship had to go to a shipyard for repairs later.

Figure 10. ASIAN BREEZE, tear to the bulbous bow.
