## *Final report RS 2018:04e*

ATLANTIC – Grounding outside of  
Oskarshamn, Kalmar County on  
23 September 2017

File no. S-154/17

21 August 2018

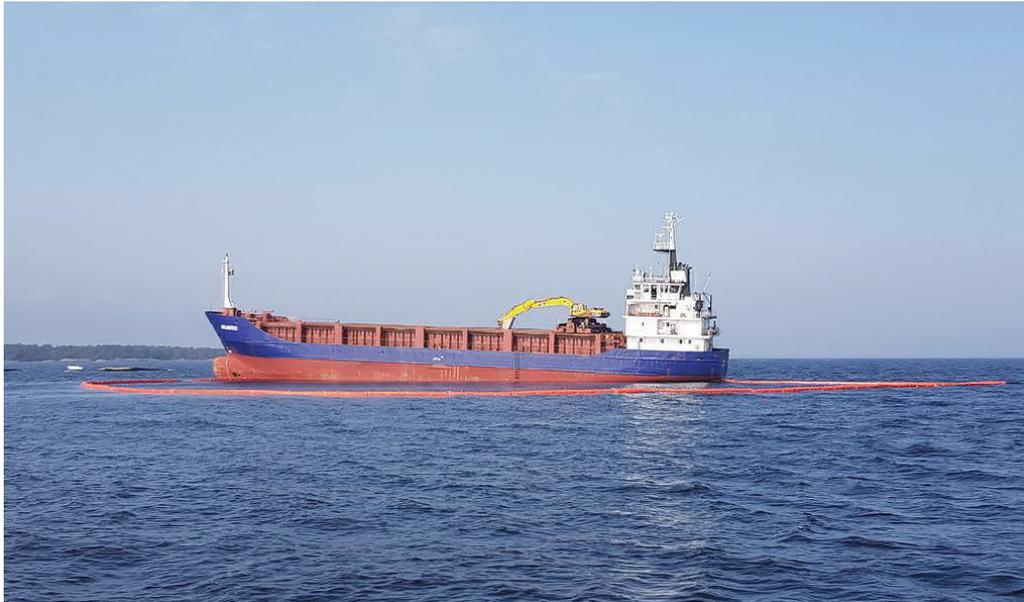
Figure 1. ATLANTIC aground. Image: Swedish Coast Guard.

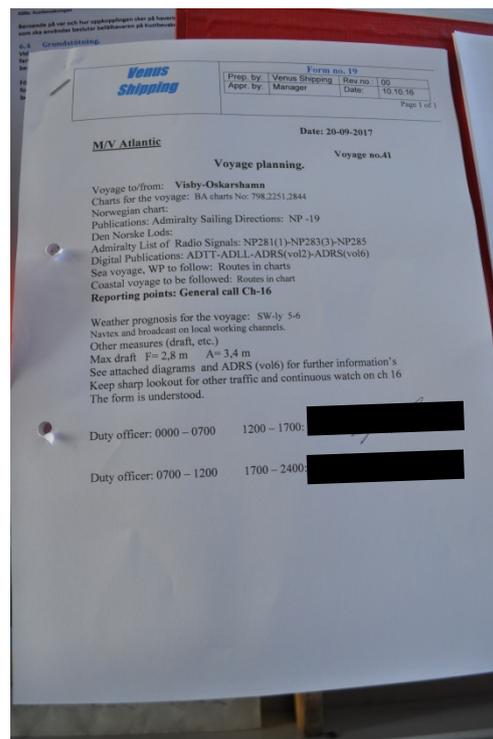
The chief officer completed the voyage plan to Oskarshamn. The voyage plan consisted of a first page containing information regarding charts, publications and weather (see figure 2). The second page of the voyage plan consisted of turning points and courses, as well as the distances between these.

Figure 2. Voyage plan of the ATLANTIC.

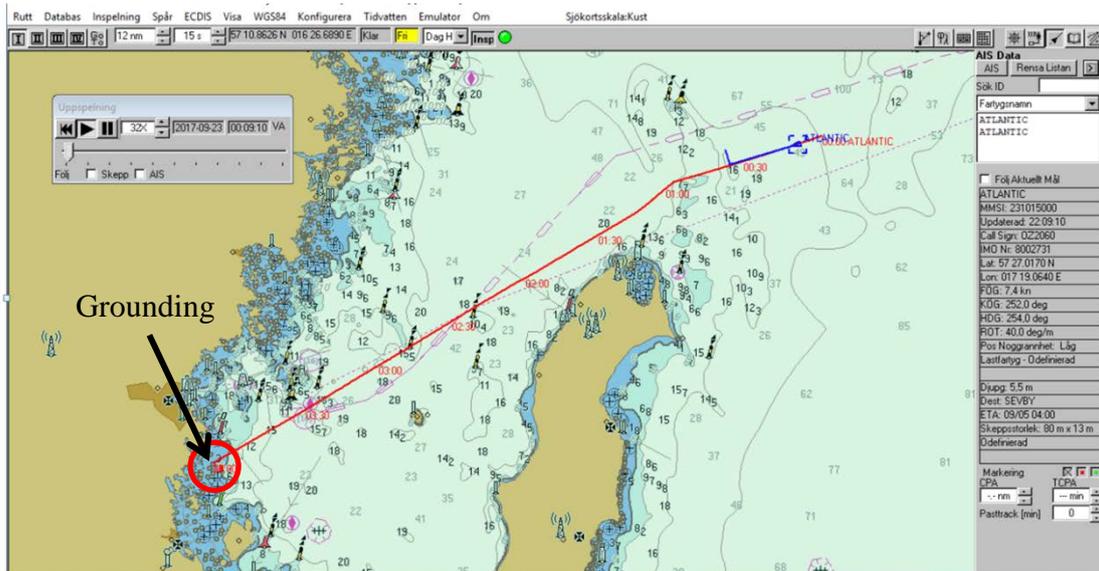
Figure 3. AIS track of the ATLANTIC.

According to the master, he turned north of Öland (see Figure 3), but shortly afterwards he fell asleep on the bridge and only woke up when he heard someone call the ATLANTIC over the VHF<sup>4</sup>. It turned out to be a pilot boat that had noticed the ship's position.

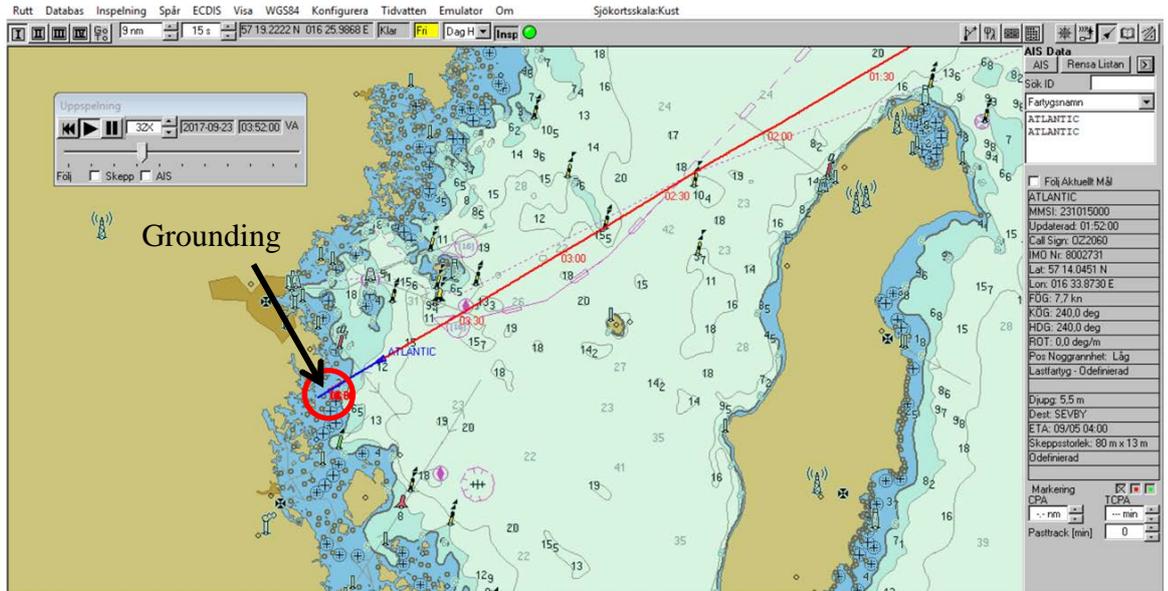
Shortly afterwards, just after four o'clock in the morning on 23 September, the ATLANTIC ran aground (see figure 4).

Figure 4. AIS track of the ATLANTIC.

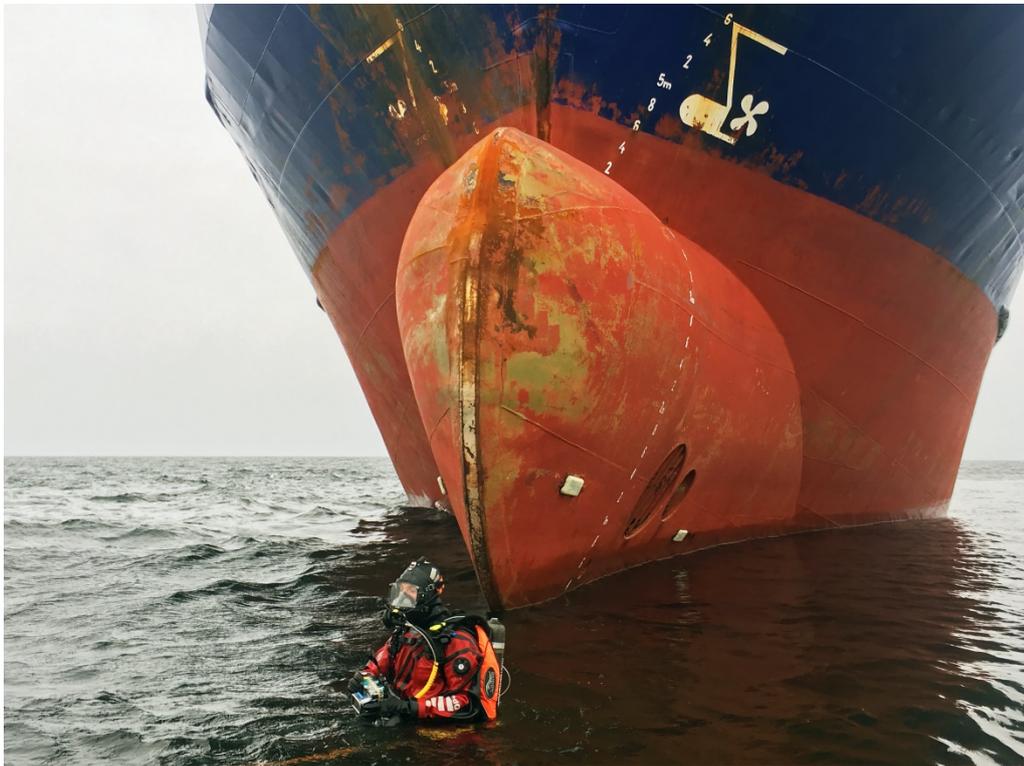
Figure 5. The ATLANTIC aground. Image: Swedish Coast Guard.

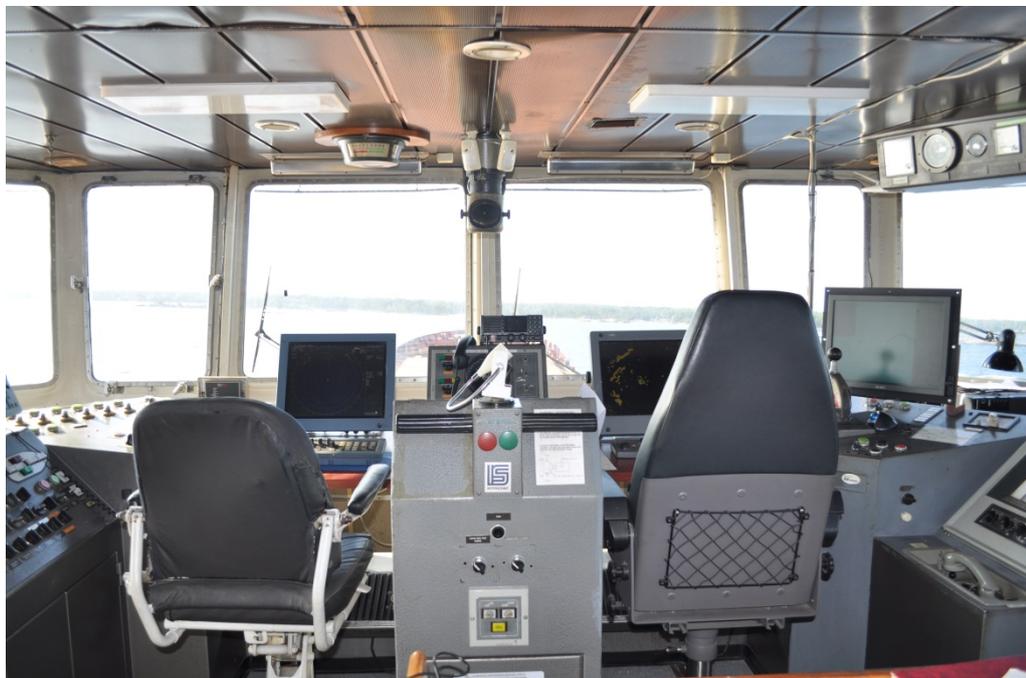
Figure 7. The bridge of the ATLANTIC.

The bridge is fitted with a console that has Anschütz autopilot, manual steering and engine manoeuvres. The navigation equipment includes two radar sets, GPS<sup>6</sup>, BNWAS<sup>7</sup> (see section 1.5.2) and GMDSS<sup>8</sup> with several VHF stations. However, there was no approved electronic navigational chart on board at the time of the accident, neither in the form of ECDIS<sup>9</sup> nor ECS<sup>10</sup>; but an electronic navigational chart was used on board which was neither up to date nor approved for navigation.

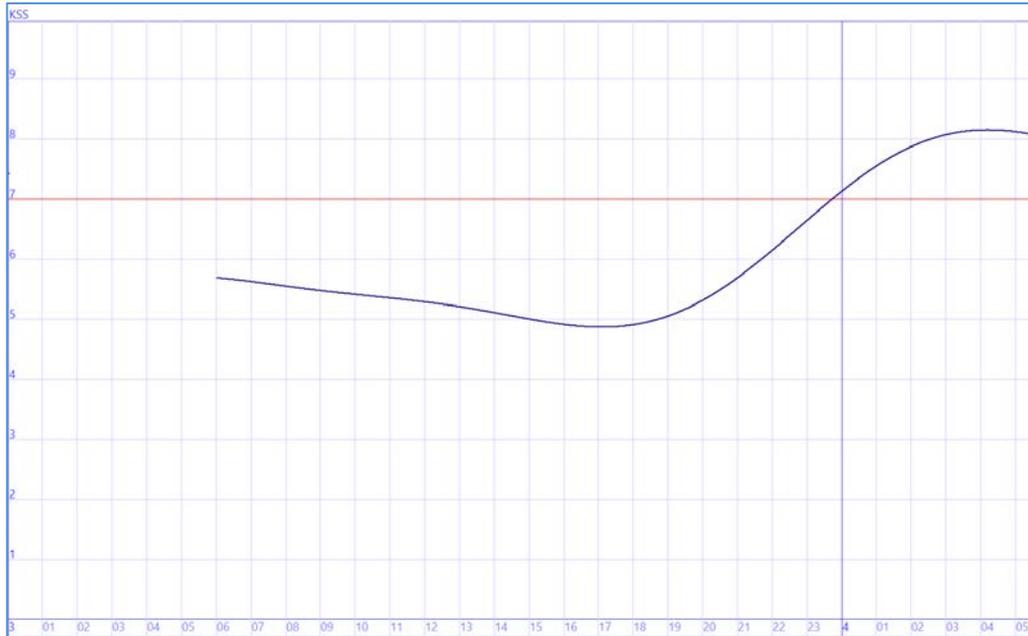
Figure 8. Model of tiredness levels for the master in the 24 hours leading up to the grounding. The software SWP – The Sleep Wake Predictor version 3.12.0 – was used for modelling.

The model indicates levels of sleepiness above eight on the KSS from midnight to the time of the grounding. The master had not slept or rested since 06:00 in the morning on the day before. This means that when he fell asleep, he had been awake and working for approximately 22 hours, which would put him in a very sleepy state. In addition, he took over the chief officer’s night watch during hours when he would normally have his main continuous period of sleep. Furthermore, the master had a great total sleep deficit, as he usually only slept around six hours per night and because he had only slept for approximately three hours on the night between 20 and 21 September.
