Final report RS 2016:01e

BONDEN/ ASIAN BREEZE - collision in
the fairway off Malmö 16 March 2015

File no. S-37/15

22/03/2016

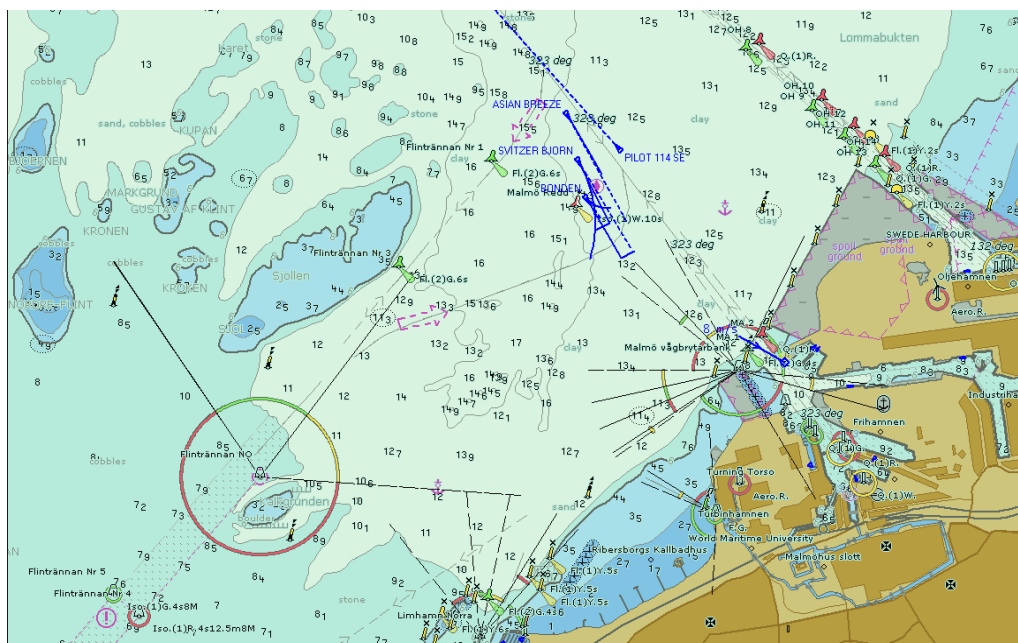
Figure 3. Pilot boat on its way out to ASIAN BREEZE. Image: AIS

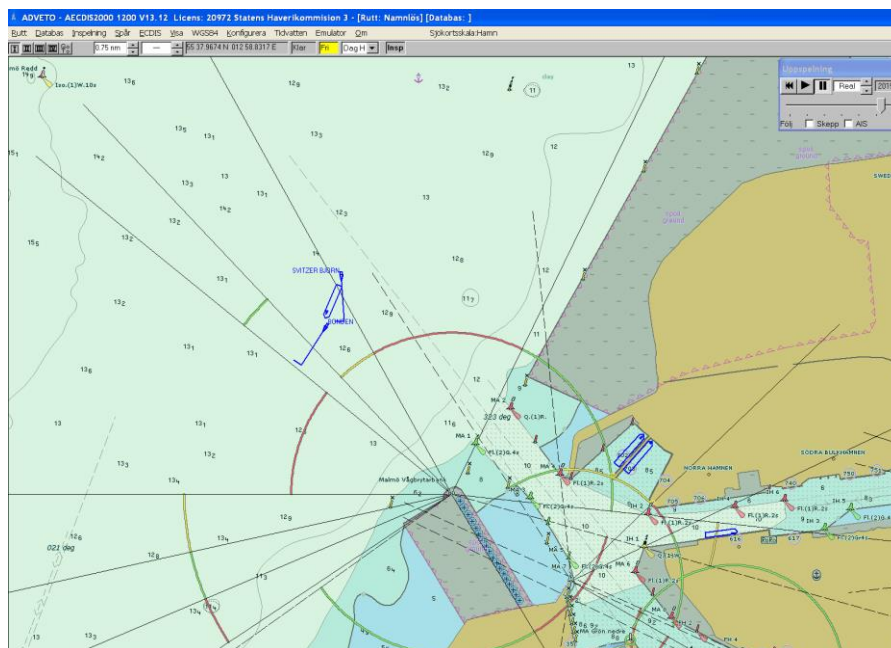
When ASIAN BREEZE was approx. 0.5 M⁴ from the first pair of buoys – MA1 and MA2 – the pilot decided to abort the harbour entry. The pilot announced that ASIAN BREEZE would turn to starboard; see fig. 6. Nevertheless, the tugboat's line was successfully secured shortly thereafter. The connection was thus completed during the turn.

Figure 6. ASIAN BREEZE turned to starboard. Image: AIS

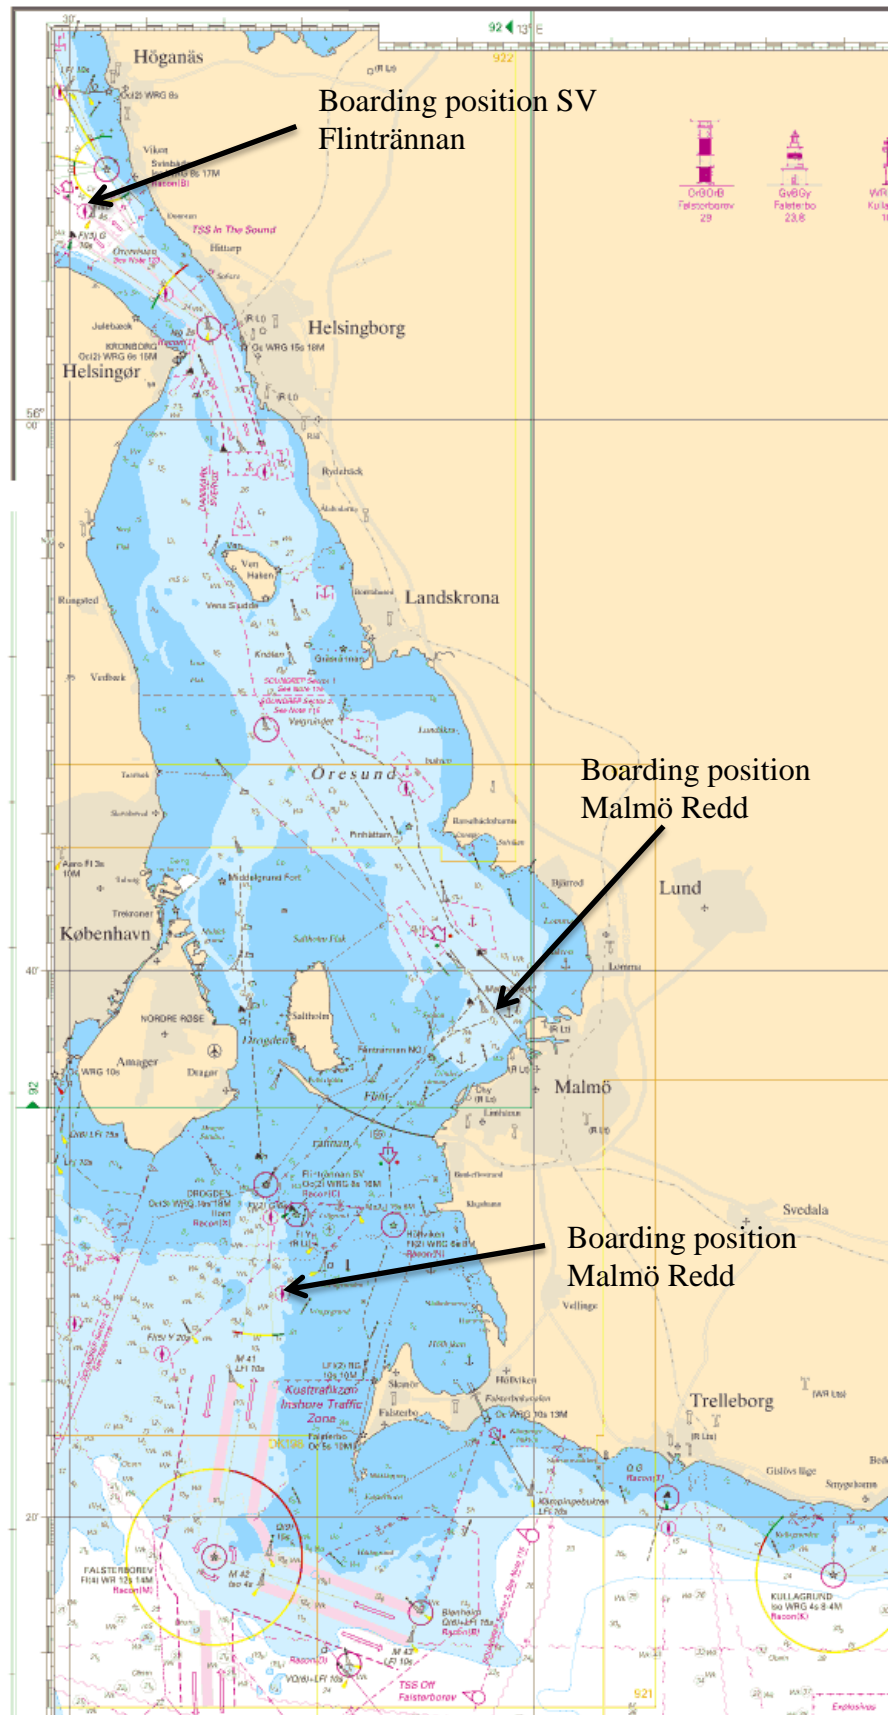
Figure 11. Öresund. Image: Swedish Maritime Administration no.: 10-01518.

The majority of car carriers approaching Malmö from the north take on a pilot north of Helsingborg by buoy M1. However, the captain of ASIAN BREEZE had been in Malmö a number of times and was very familiar with its fairway. He therefore did not take on a pilot until the ship reached Malmö Redd; see figure 11. When connecting several tugboats, it is standard procedure for the pilots to embark earlier and at a point further out than the boarding position marked out in the navigational chart.

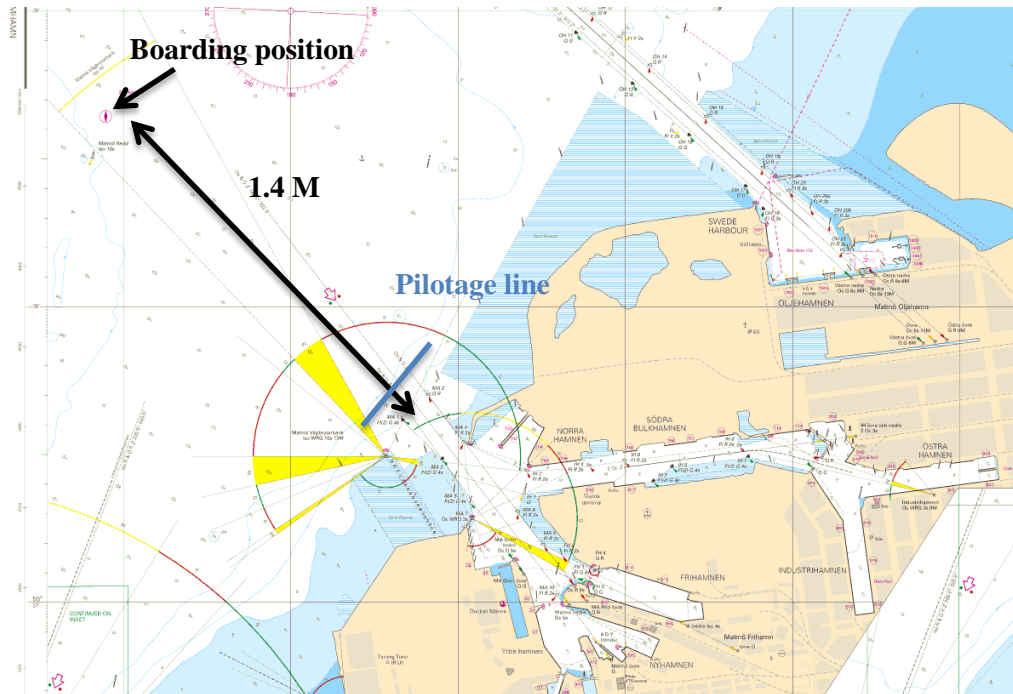
Figure 12. Malmö port Photo: Swedish Maritime Administration no.: 10-01518.

The distance from the pilot boarding position marked in the navigational chart to the first buoy pair MA1 and MA2 is 1.4 M. The pilotage line runs between the positions 55°37.56N 012°58.15E and 55°38.00N 012°58.95E.

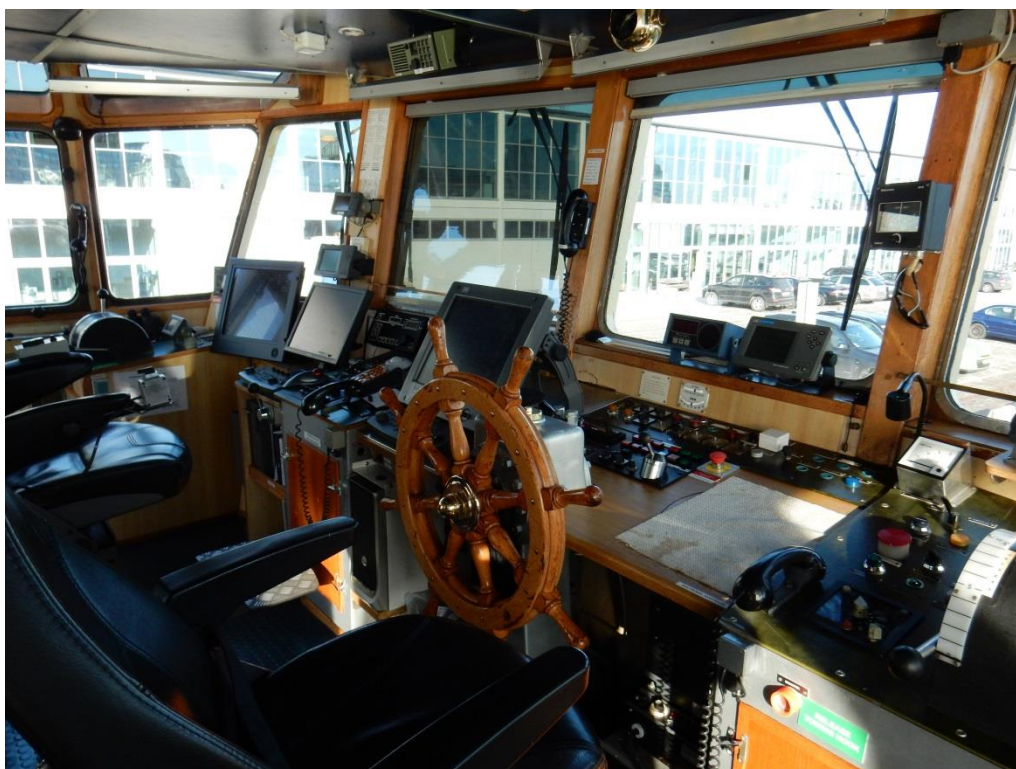
Figure 13. BONDEN - The bridge.

BONDEN is a conventional tugboat with a propeller and a bow thruster and a bollard pull of 38 tons. Conventional tugboats are not uncommon in the area in question. Conventional tugboats have less manoeuvrability and are less stable when towing compared with a tractor tug⁶ or an ASD⁷ tug. At the time, BONDEN was being used as a support vessel and was moved between different ports as required.

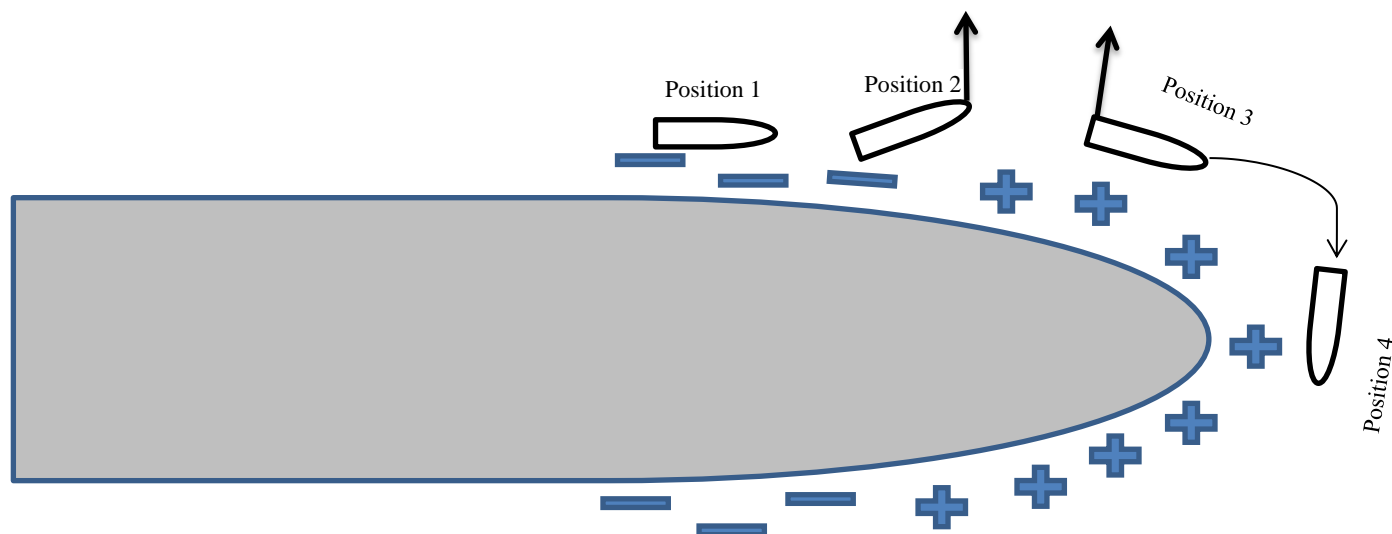
Figure 15. Interaction along the ship's exterior.

Position 1: The same conditions prevail all the way along the side of the ship. If the tugboat comes too close to the ship, it can be dragged in towards its side.

Position 4: This position, i.e. ahead of the bow, is naturally hazardous due to the risk of collision and should be avoided.

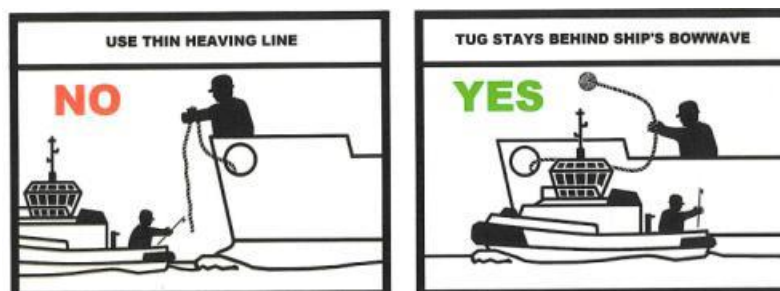
Figure 16.

According to the Guidelines for Safe Harbour Towage Operations, a heaving line with an appropriate weight should always be used and

thrown down to the tugboat as far astern as possible from the bow; see figure 16. According to the guidelines, it should also be checked beforehand – preferably via VHF – whether the tugboat has a messenger line on its towline. The weight attached to the heaving line should be made of leather, woven fabric or plastic and filled with a maximum 0.2 kilos (approx.) of sand so that it does not entail a risk of injury to the tugboat crew. The ship's speed should only be 2-6 knots through the water and a steady course should be pursued.
